**SHAMROCK CHAMBERS  
59, 60 & 61 DAME STREET AND  
1 & 2 EUSTACE STREET  
DUBLIN 2**

**ARCHITECTURAL HERITAGE  
IMPACT ASSESSMENT:**

**29<sup>th</sup> October 2025**

**1146/02**

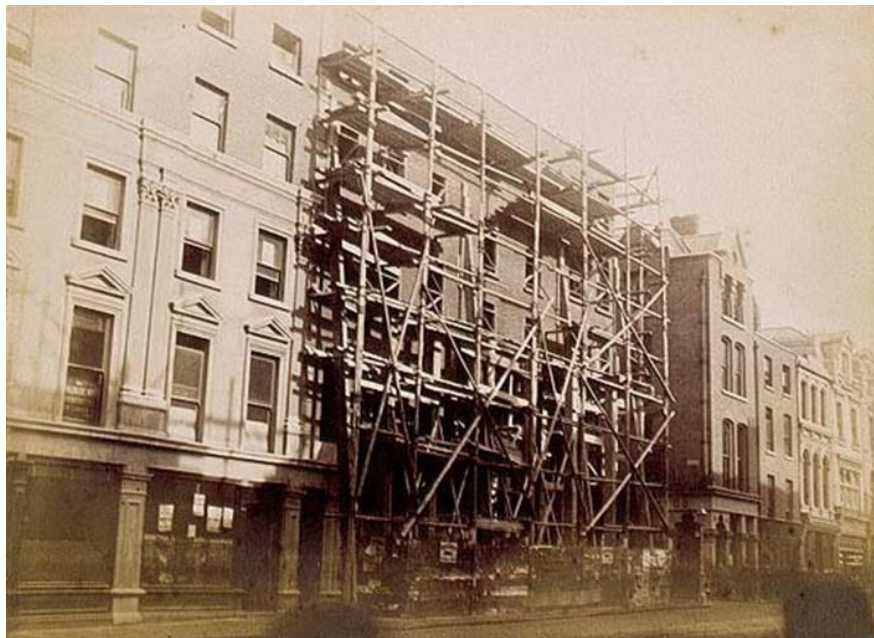
*Plate 2: Overall view of Dame Street frontage, October 1890*

The second image shows the entire Dame Street frontage scaffolded for the works, taken on the same day in October 1890.

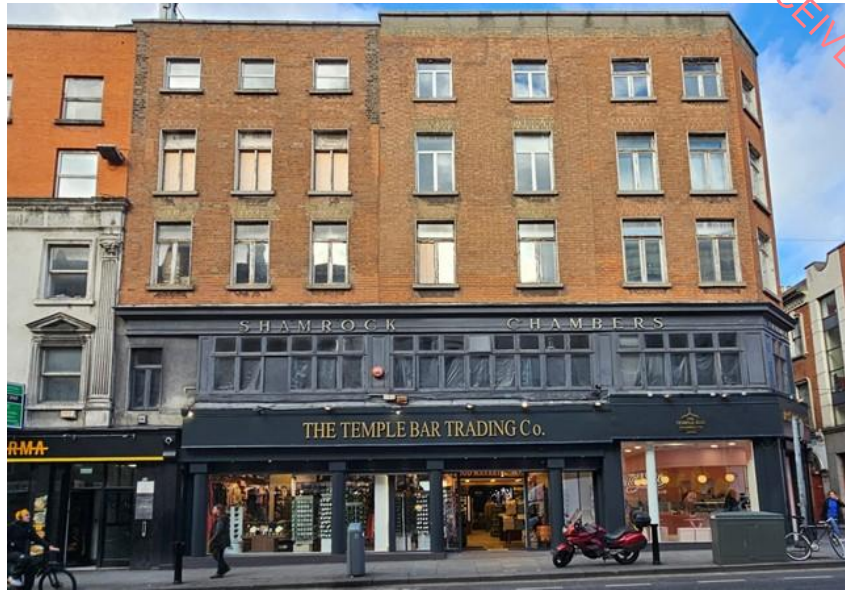
*Plate 4: Numbers 59-61 Dame Street*

Numbers 59-61 Dame Street has a seven-bay frontage to Dame Street with three brick floors over a double-height shopfront which has a deep fascia supported on columns in the western shop unit. The eastern shop unit has a deeper fascia and wraps around the corner into Eustace Street via a chamfered corner. The shopfront has clerestory lights above which is a fascia bearing the name Shamrock Chambers. The timber casement windows on the upper floors have horizontal top lights and a lower section divided vertically. The building is topped with a parapet with an upper section of concrete topped with copings. The brickwork is mostly red with some variation in colour and with some yellow brick. Number 61 is slightly lower than the rest of the frontage and in the upper floors has darker brick bands at either side of the elevation.

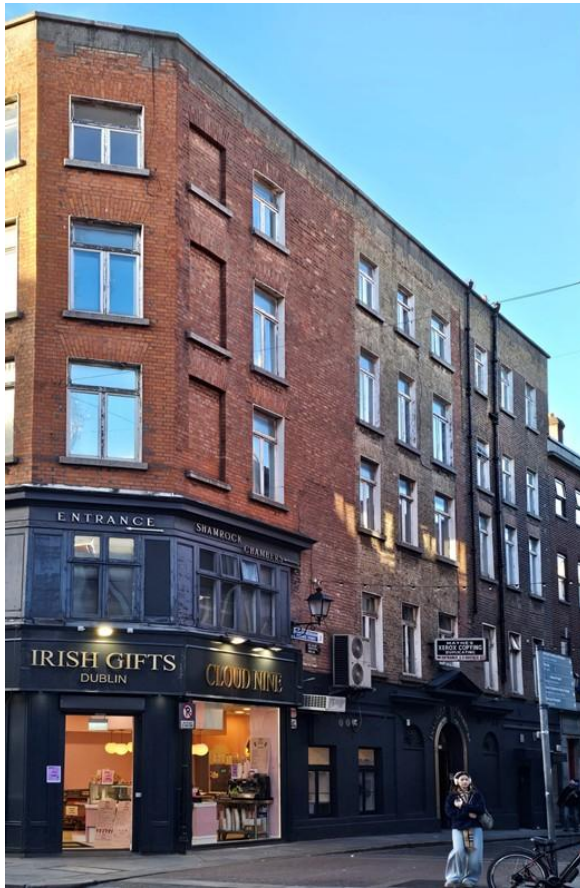
The Eustace Street façade is in three sections, representing the original plots at 59 Dame Street and 1 and 2 Eustace Street. The Dame Street element is two-bay, the left-hand bay being blind. The double-height shopfront wraps around the chamfered corner onto this frontage.

The central section, formerly 1 Eustace Street, is faced with yellow brick, unevenly keyed into the masonry on either side. This element is three-bay with four storeys over the ground-floor entrance.

The northern, or right-hand element is the former 2 Eustace Street and is faced with red brick. The ground-floor level is faced with smooth render. The windows in all sections are timber casements.

*Plate 6: Eustace Street frontage*

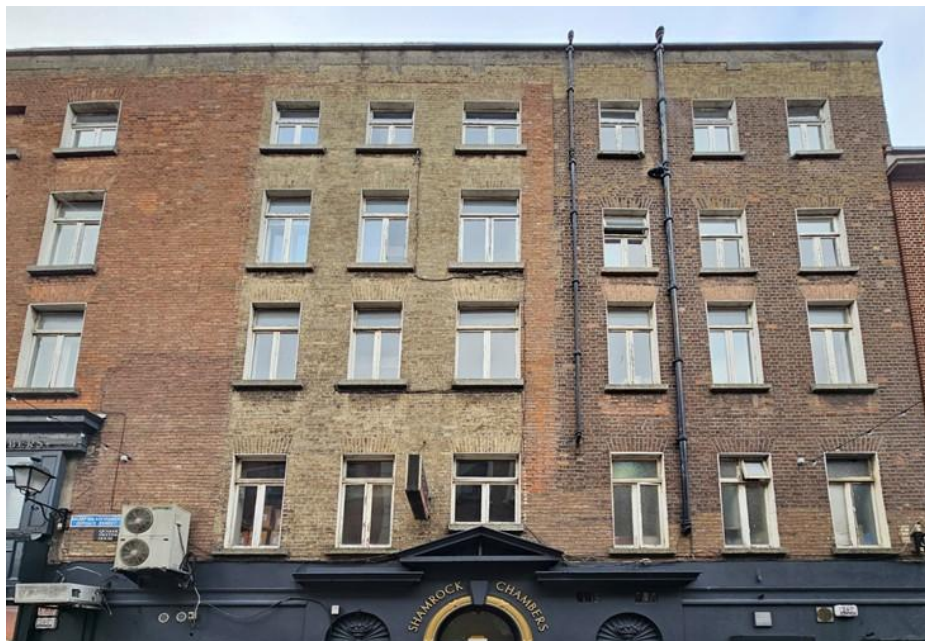
The photograph below shows the central section of the Eustace Street façade, with the different areas of red and yellow brickwork. This contrasts with the rendered ground-floor entrance and its flanking windows. The timber casement windows are also evident.

*Plate 7: Central section of the upper floors on the Eustace Street façade*

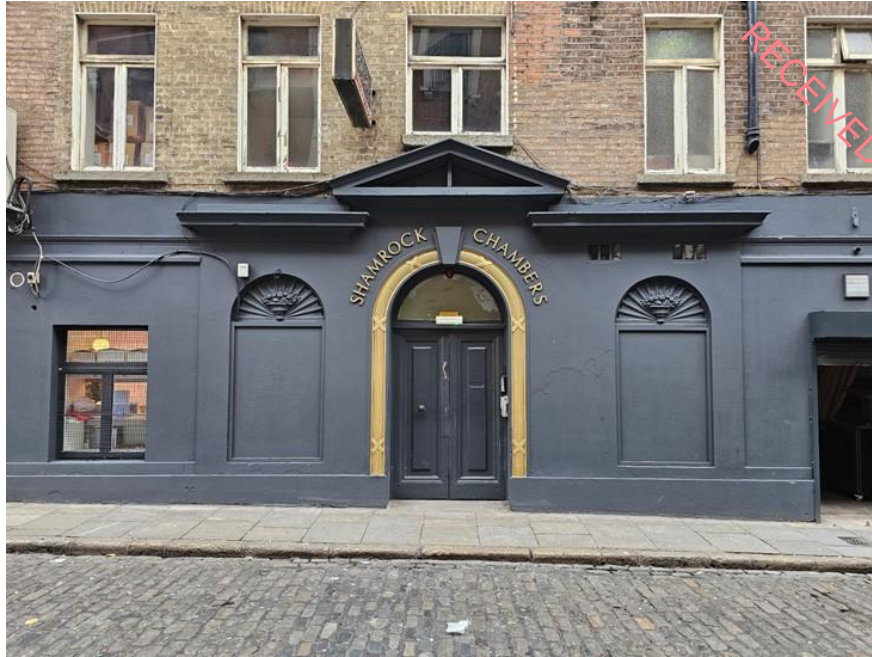
*Plate 8: Entrance to Shamrock Chambers with flanking windows*

The entrance to the building has a reeded surround, with keystone and is set in a rendered ground-floor façade surmounted by a pediment that is flanked by corncicing over the adjacent windows. The windows on either side are timber casements with opening top lights and are surmounted by a semicircular fan pattern with a bowl of fruit at centre. The windows are currently covered over for security reasons.

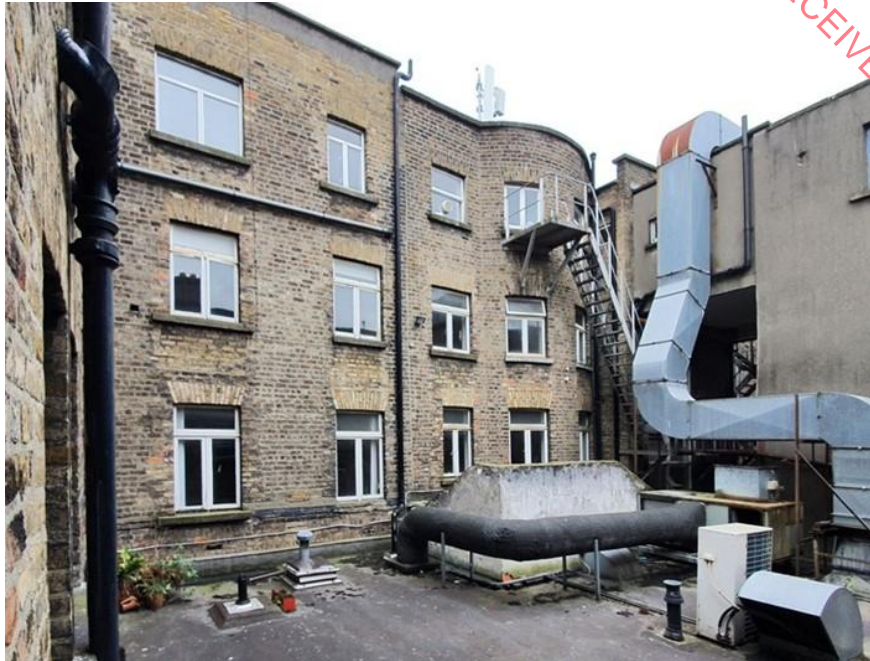
*Plate 10: Northern elevation, rear of 60 and 61 Dame Street*

The rear of the buildings in both Dame Street and Eustace Street are constructed with yellow stock brick. The rear of number 61 Dame Street is bowed, with the bow off-centre toward the west. The windows are timber casements with top-hung upper lights, below which the windows are divided vertically. The windows are all on the same level with the window heads and the sills aligned. There is some variation in colour of the brickwork, indicating that alterations have been made in the past.

A steel fire escape descends from the bow at the top of number 61 Dame Street.

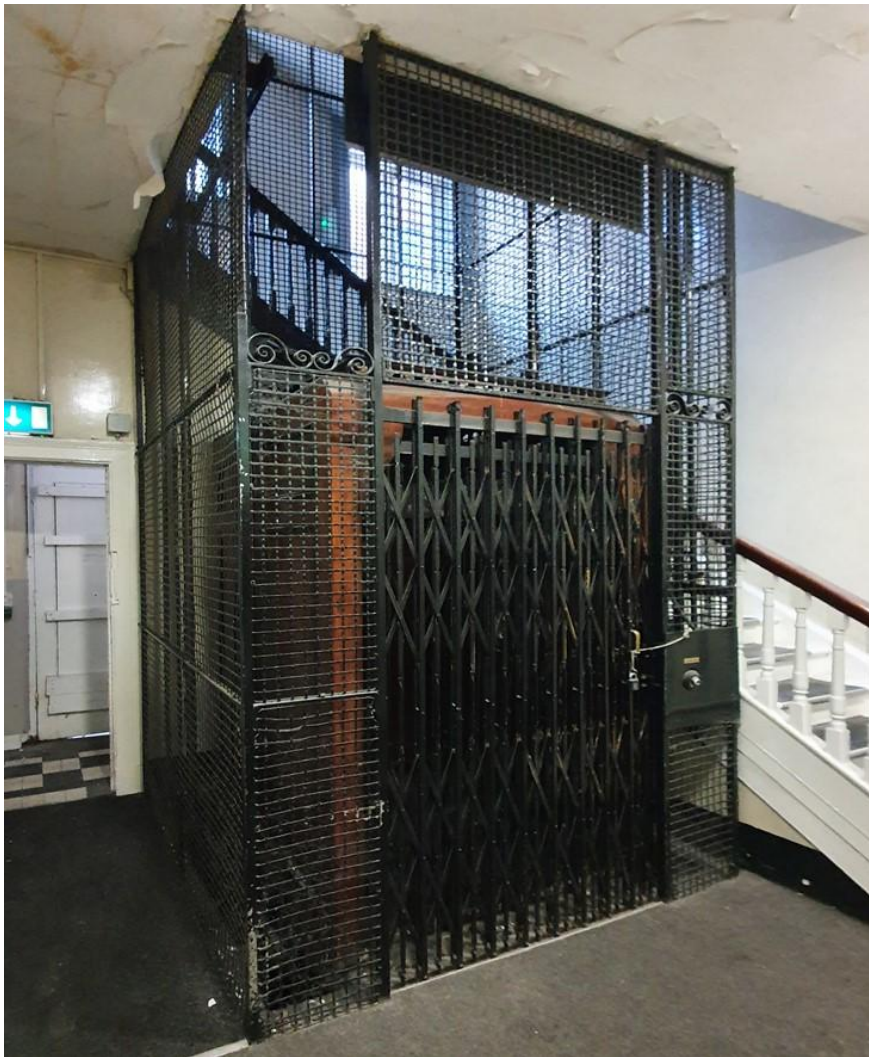
*Plate 11: Cage lift at ground-floor level*

The cage lift is comprised of a square-section steel frame infilled with woven steel mesh. The lift gates are of the concertina type, with interconnected steel bars and hung on a steel rail by means of pulley wheels. To the front of the cage there is wrought-iron scrollwork at the top of the mesh on either side of the lift door. The lift car is of hardwood and is slung from the upper levels by means of steel cables. This lift requires a lift attendant as it is not automated.

Some modifications to the lift mechanism and the track guides will be necessary to comply with standards. Replacement of timber in the machine room will also be necessary, the new materials to be non-combustible.

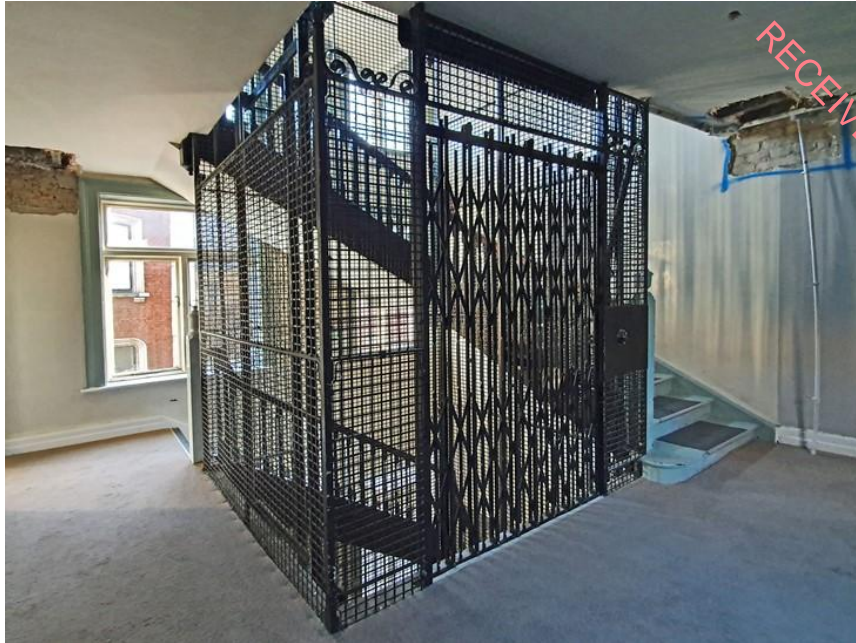
*Plate 12: Lift cage at first-floor level*

The lift serves the ground floor and upper floors and is set into the stair well, with the stairway running around the sides of the cage. The lift cage on the upper floors is similar to that on the ground-floor level.

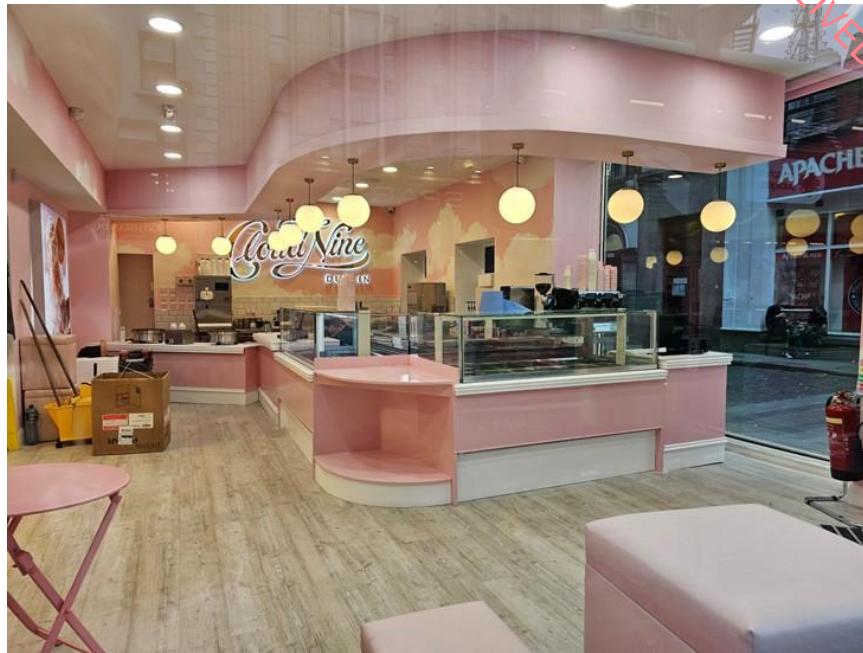
Plate 14: Corner shop unit on ground floor of 59 Dame Street

The shop units on the Dame Street frontage have been fitted out to serve their use as a retail unit. No historic fabric has been identified in these areas.

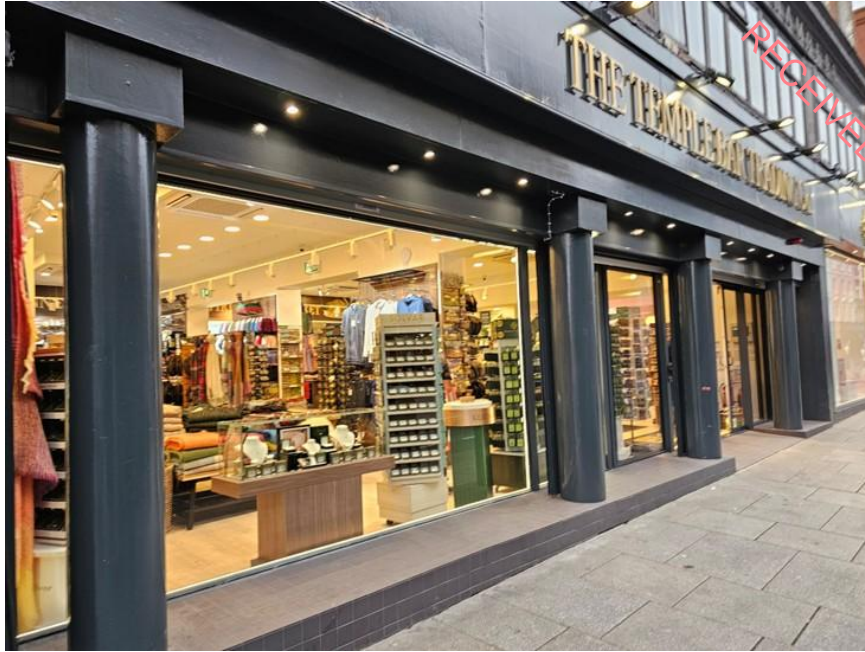
*Plate 16: Shopfront at 60-61 Dame Street*

As was seen in the historical background above, the three buildings were amalgamated into a single retail unit in the 1850s and substantial reconstruction was carried out in 1890, again in 1909 and in the 1930s. It appears that the present shopfront dates from no earlier than the 1930s, based on the earlier image of Lipton's shop shown in Plate 3 above. At ground-floor level this consists of a series of plain columns with box capitals rising from a tiled plinth.

rear, and the other at the western, or left-hand end, where a cylindrical column would be boxed in to form a pilaster, giving greater solidity to the margin of the shopfront. As the spacing of the columns is not symmetrical at present an additional column is to be introduced at left in the shopfront at number 61, providing the symmetry that is visually important. The design would also reintroduce stallrisers, which are missing at present. The upper floor windows and timberwork are to be refurbished and fascia signs to be introduced above the shopfronts that would be in keeping with the proposed shopfronts below.

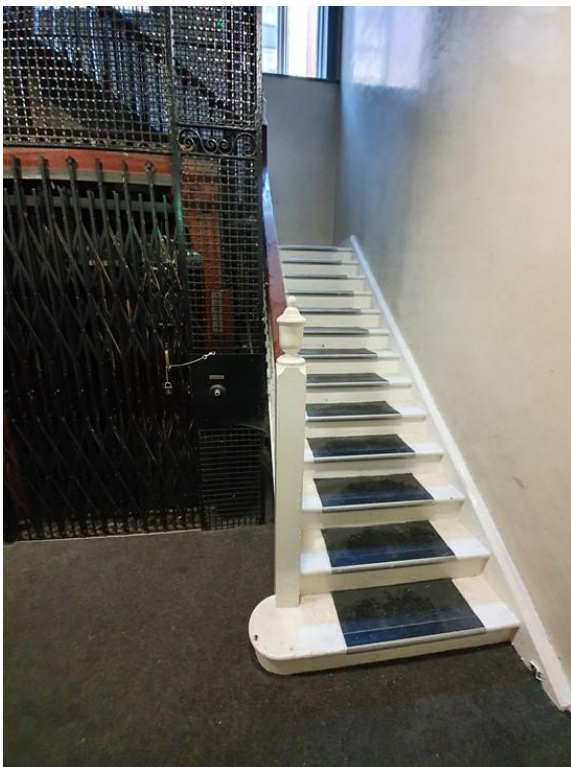
To the rear of the shop at ground-floor level the area along the Eustace Street frontage accommodates the entrance hall, stairway and the lift. The stairway is closed-string with square-section newels having urn finials.

*Plate 17: Foot of stairway on ground floor*

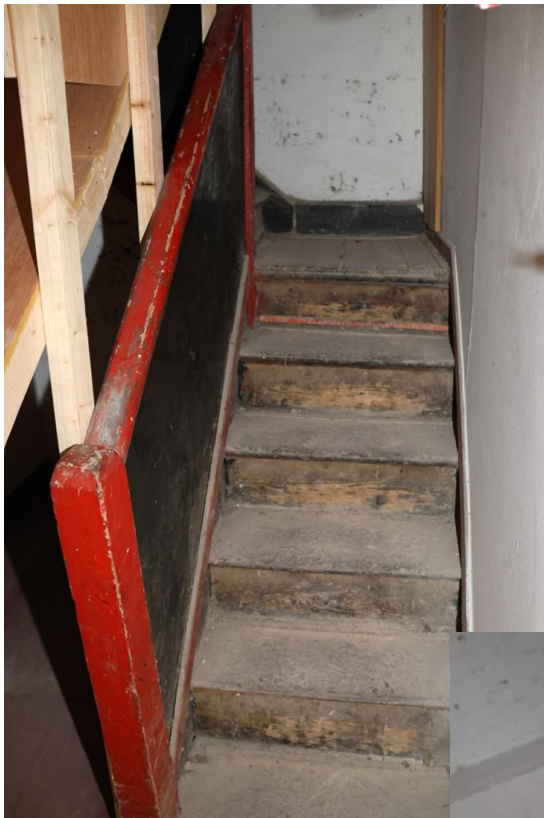
Access to the basement is via a staircase on the Eustace Street frontage, in number 2 Eustace Street. This is separate to the main staircase and leads only to the basement from the street, with no access to the rest of the building. The stairway descends through to flights at right angles. The balustrade is simple, with parallel boards at the top, newels at the top, bottom and turn, and a plain handrail, below which is a plain board. The treads and risers are of timber. The three enclosing walls of the stair well are of crudely laid brick in English garden wall bond.

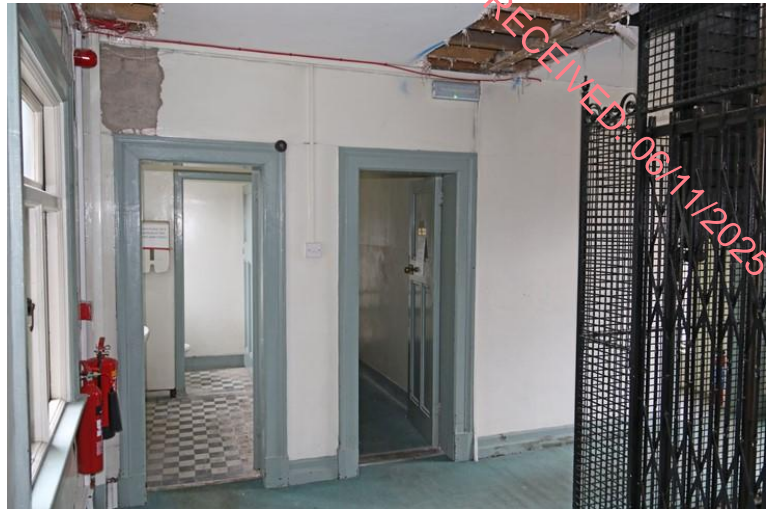
*Plate 21: Landing at lift cage*

The ceilings in this area are of plasterboard and the floors are boarded. The doors are generally three-panelled, with a single panel at the top and two vertical panels below. Each doorway has a timber architrave.

By the end of the 1920s, Lipton's no longer needed the upper floors. The property was converted into small office suites to the designs of architects Kaye-Parry, Ross and Hendy and given the name Shamrock Chambers in honour of the founder's yachts. From this time a dozen or more businesses occupied chambers in the building. It was at this time that the existing cage lift was inserted into the stairwell.

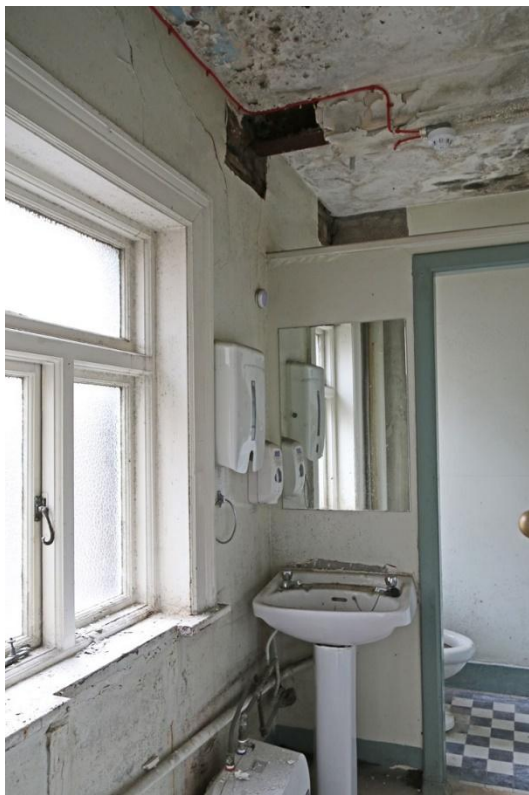
*Plate 22: Typical bathroom*

The sanitary ware in the WCs is comprised of late replacements.

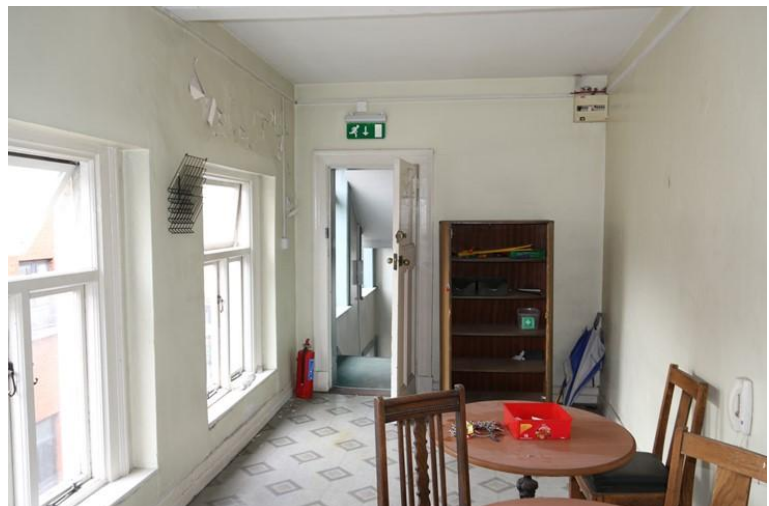
*Plate 23: Room on Eustace Street frontage*

The windows are timber casements with top light and two lower sashes, one of which is side hung. Many of the windows have timber architraves, though not all.

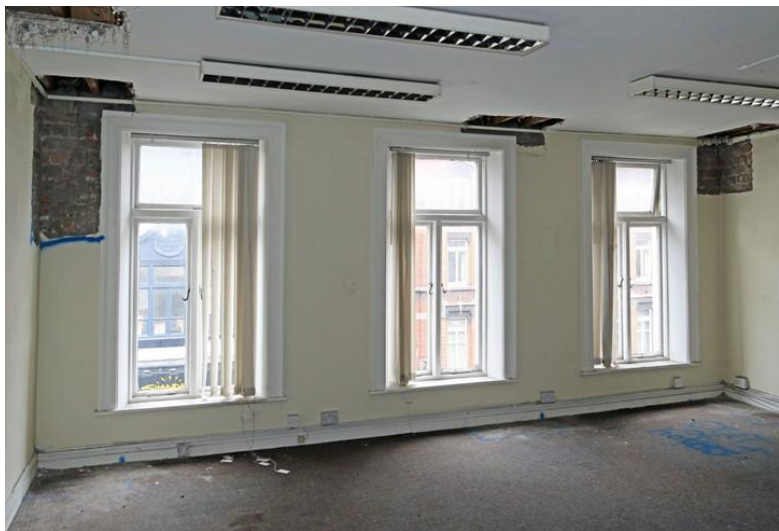
*Plate 25: Room on Dame Street frontage*

The north-south internal walls are mainly of brick, though some are timber stud faced with plasterboard, as are the east-west walls.

The windows are timber casements with top light and with side-hung sashes below the transom.

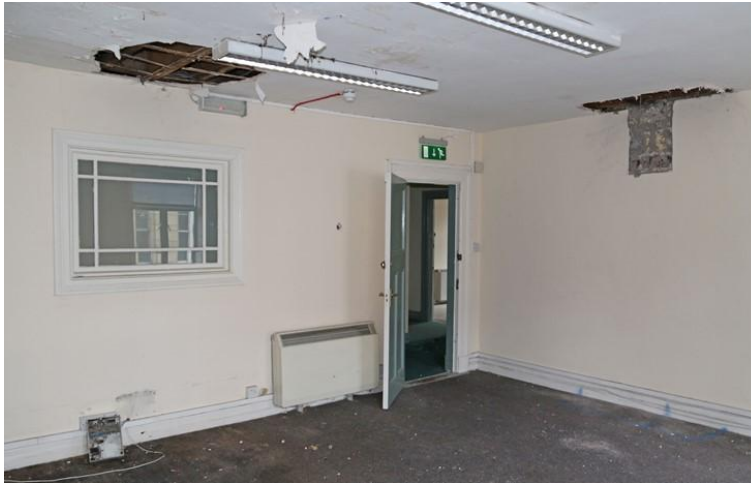
At the rear of some of the front offices are glazed panels designed to provide borrowed light to the corridor beyond.

Plate 27: Office with glazed panel to corridor

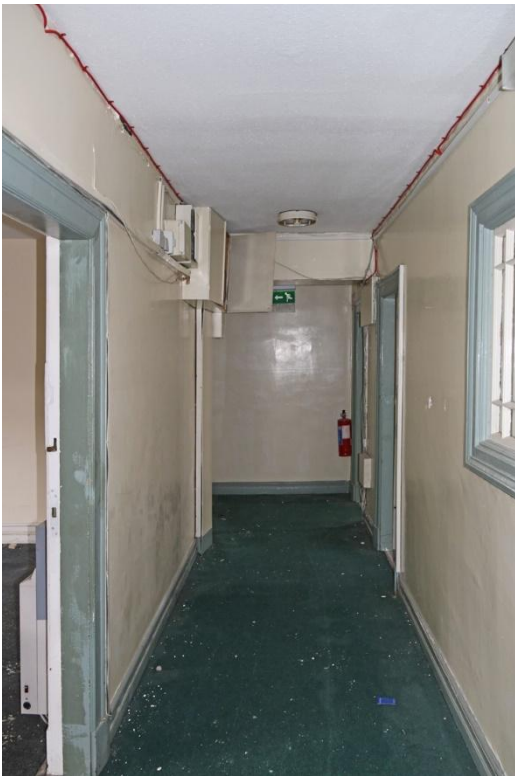
Plate 28: Typical corridor

The offices are accessed via corridor that runs along the centre of the building, moving southward from the stairway and turning west along the Dame Street side. This divides the building unevenly, the offices on the Dame Street side being deeper than those at the rear.

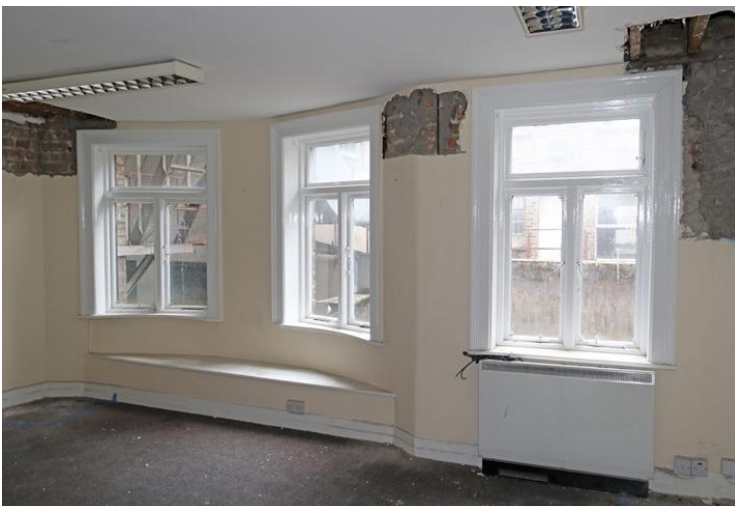
Plate 29: Rear windows in bow

Offices at the rear of the building look out onto the light well behind the building. These are fitted out with doors, windows, ceilings, floors etc similar to those elsewhere. The office at the western end at second- and third-floor levels includes the bow at the rear of the former 61 Dame Street.

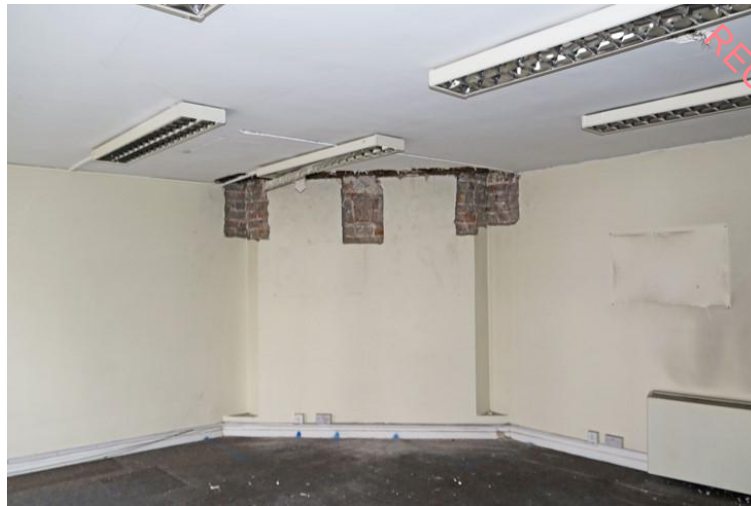
*Plate 30: Corner chimneybreast in front room*

At the western end of the building at second- and third-floor levels there is a substantial corner chimneybreast. The fourth floor is not part of Shamrock Chambers, while the chimneybreast is missing at basement, ground floor and first floor. The chimneybreast is closed up with no evidence that the hearth has been open for some time, there being no scars in the plaster. At the rear of the building the chimneybreast is partially within small storage rooms, with a small part projecting into the rear office.

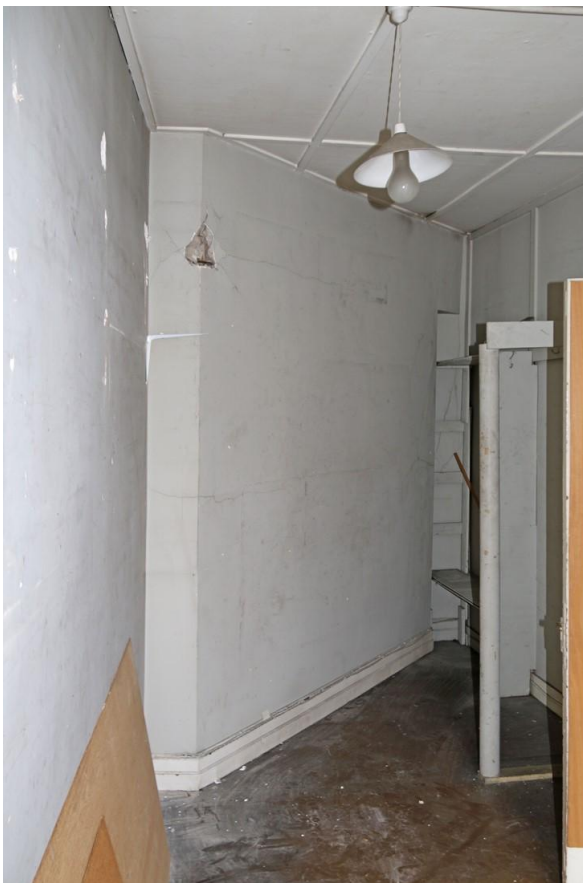
The adjacent photograph shows the chimneybreast in a store.

*Plate 31: Corner chimneybreast in store*
